**Flood Control Project Maintenance
Levee Inspections**

2008 Channel Summary Report

Merced Irrigation District

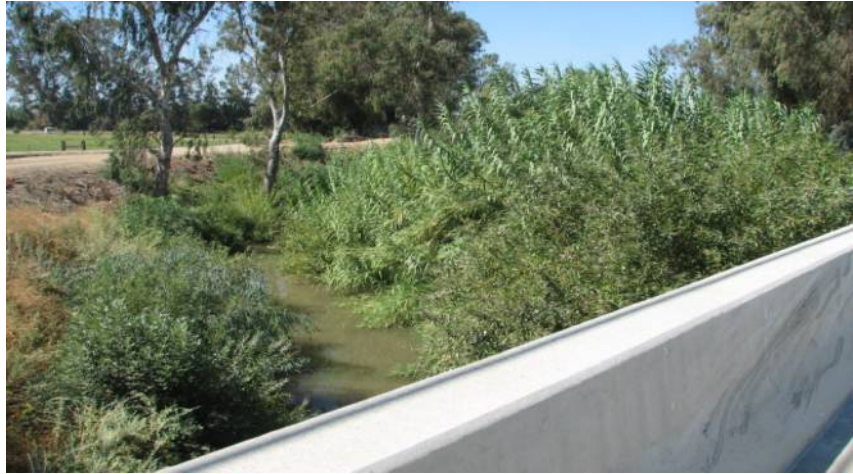
Report Line	1
Location	
Category	Rivers, Channels & Designated Floodways
Item	Vegetation & Obstructions

Downstream from Highway 140.

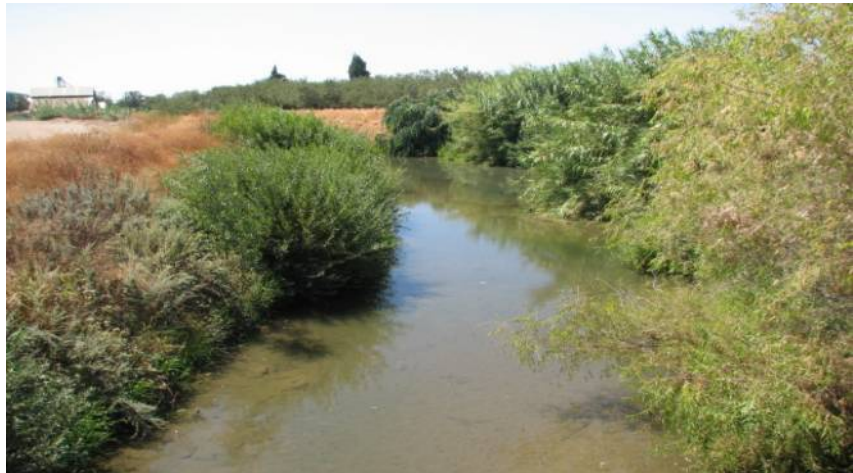
Report Line	2
Location	
Category	Rivers, Channels & Designated Floodways
Item	Vegetation & Obstructions

Downstream from Franklin Road vegetation on both banks

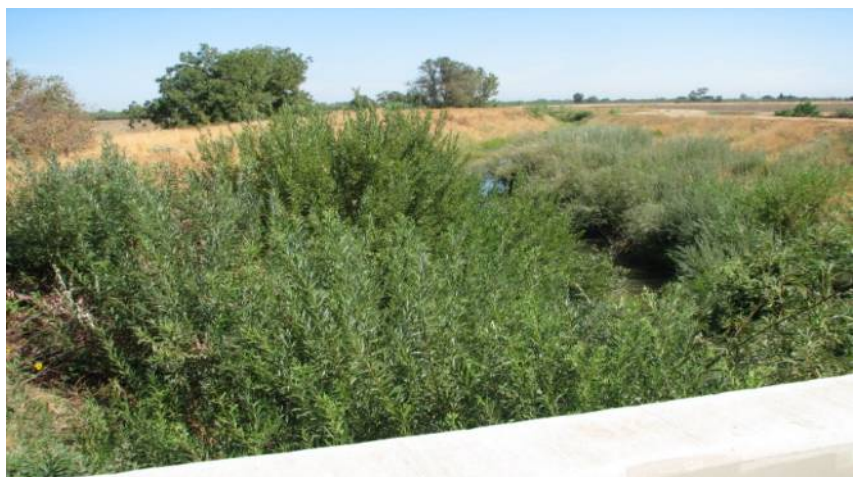
Report Line	2
Location	
Category	Rivers, Channels & Designated Floodways
Item	Vegetation & Obstructions

Upstream of Highway 140, dense growth in channel at bridge.

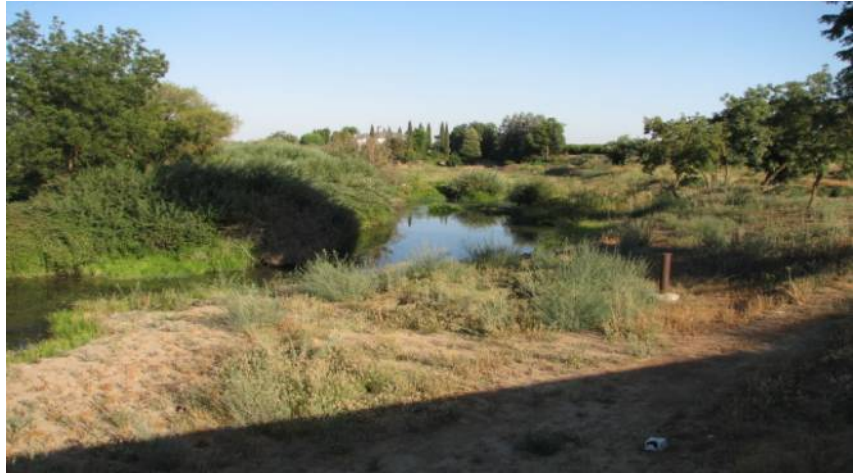
Report Line	6
Location	
Category	Rivers, Channels & Designated Floodways
Item	Erosion

Upstream from Aroboleda Drive

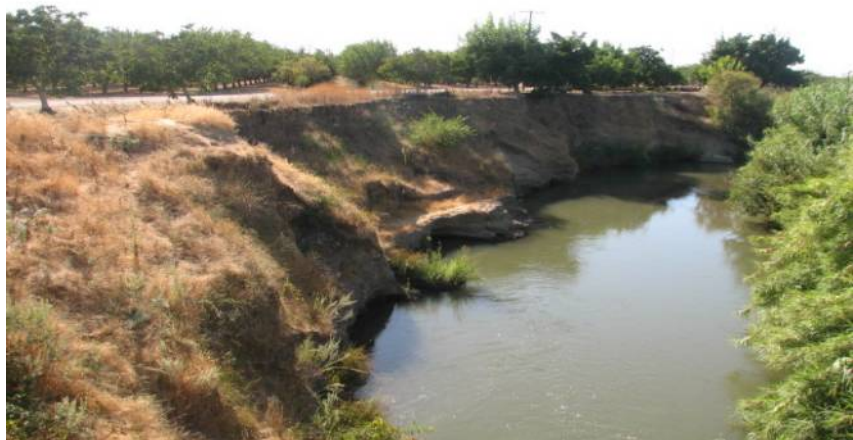
Report Line	6
Location	
Category	Rivers, Channels & Designated Floodways
Item	Erosion

Bank washed away downstream from Kirby Road, this erosion has increased from 2004 and 2005 report.

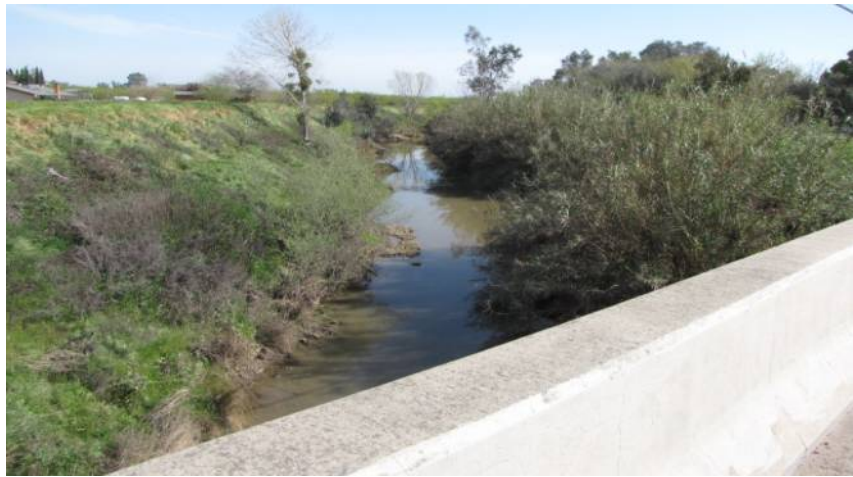
Report Line	4
Location	
Category	Rivers, Channels & Designated Floodways
Item	Vegetation & Obstructions

Looking upstream Black Rascal Creek from Highway 140. Buhac Road in background (right bank). Growth of willows and Bambo in channel left bank.

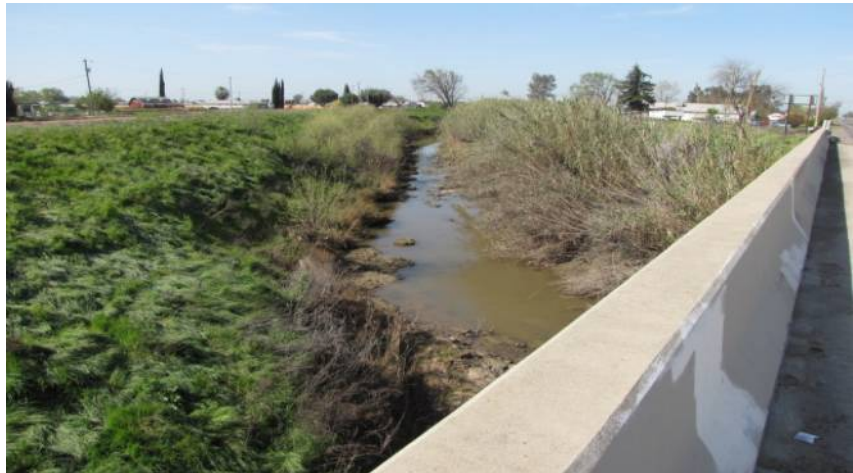
Report Line	5
Location	
Category	Rivers, Channels & Designated Floodways
Item	Vegetation & Obstructions

Looking upstream Black Rascal Creek from Highway 140 bridge. Growth of bambo on left bank.

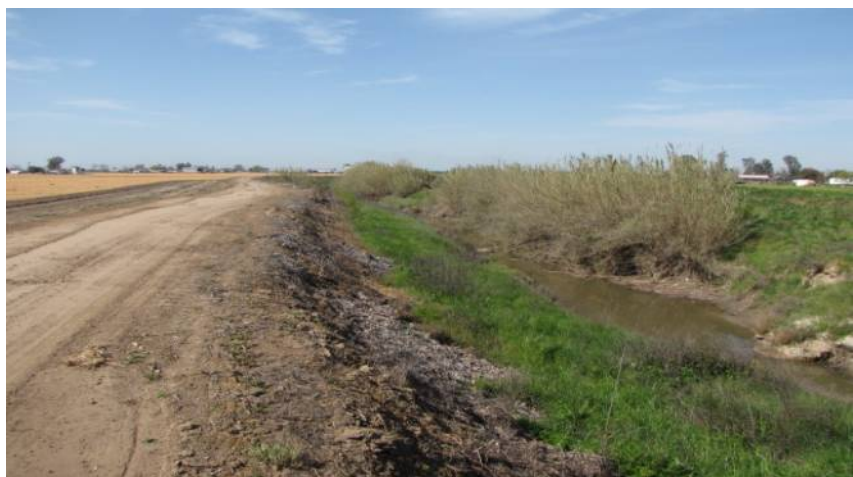
Report Line	6
Location	
Category	Rivers, Channels & Designated Floodways
Item	Vegetation & Obstructions

Looking downstream Black Rascal Creek from left bank levee. There is a presence of Bambo on right bank.

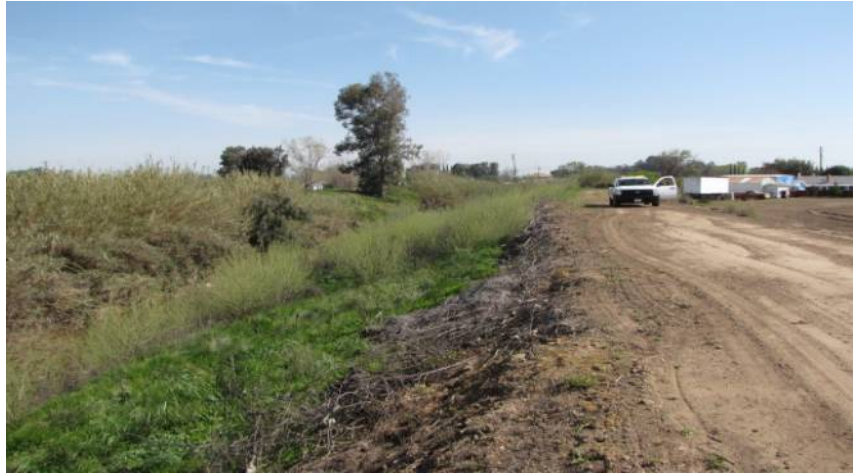
Report Line	7
Location	
Category	Rivers, Channels & Designated Floodways
Item	Vegetation & Obstructions

Looking upstream Black Rascal Creek from left bank Presence of Bambo on right bank.

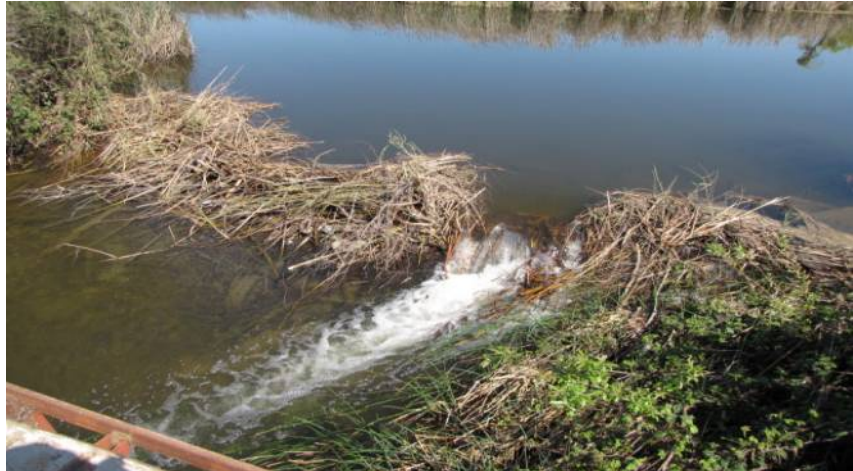
Report Line	1
Location	
Category	Rivers, Channels & Designated Floodways
Item	Vegetation & Obstructions

Looking upstream of the Burns creek at a constructed earthen dam upstream of flat car bridge. This location is a part of the Flying Jay Ranch off Bear Creek Drive.

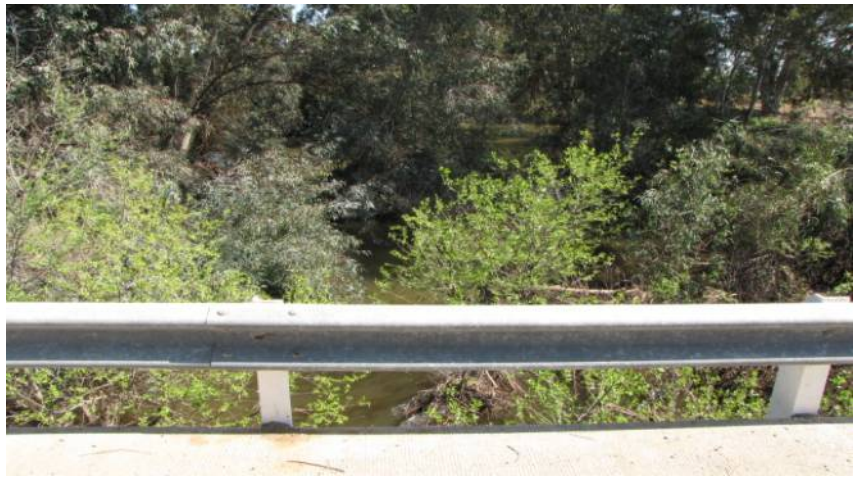
Report Line	1
Location	Water Side
Category	Rivers, Channels & Designated Floodways
Item	Vegetation & Obstructions

Looking upstream Mariposa Creek from Fresno Road bridge crossing. Vegetation in channel.

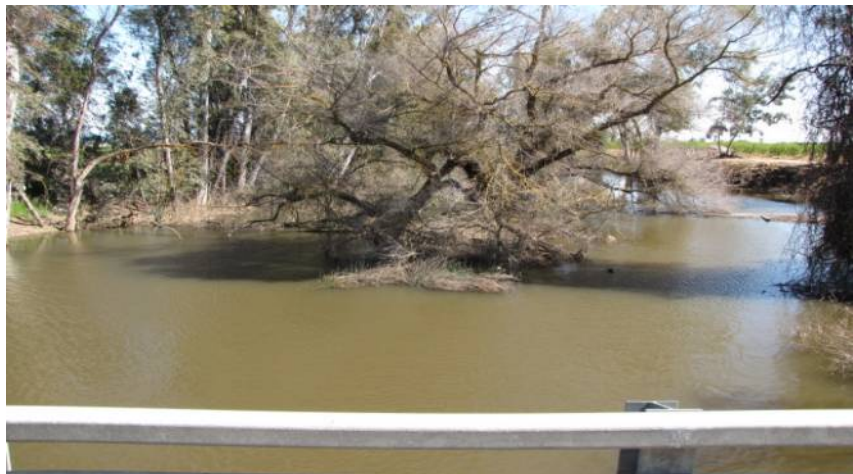
Report Line	3
Location	Water Side
Category	Rivers, Channels & Designated Floodways
Item	Vegetation & Obstructions

Looking upstream Mariposa Creek from Cunningham Rd. Large trees remain in channel.

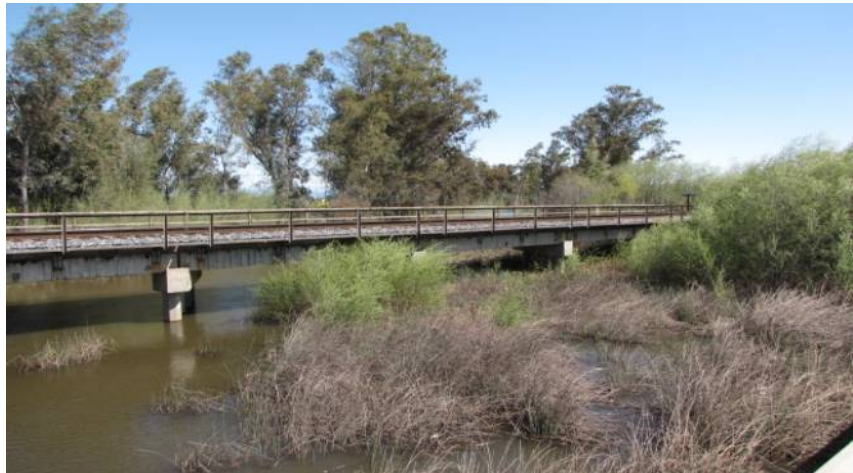
Report Line	5
Location	Water Side
Category	Rivers, Channels & Designated Floodways
Item	Vegetation & Obstructions

Looking upstream Mariposa Creek from Santa Fe Avenue. Tule growth in channel near railroad track crossing.

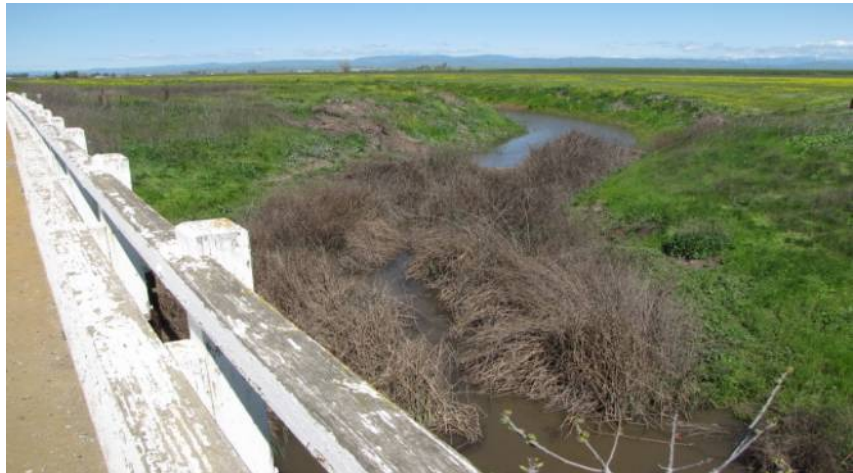
Report Line	9
Location	Water Side
Category	Rivers, Channels & Designated Floodways
Item	Vegetation & Obstructions

Looking upstream Owens Creek Diversion Channel from Burchell Avenue. Tule growth at bridge.

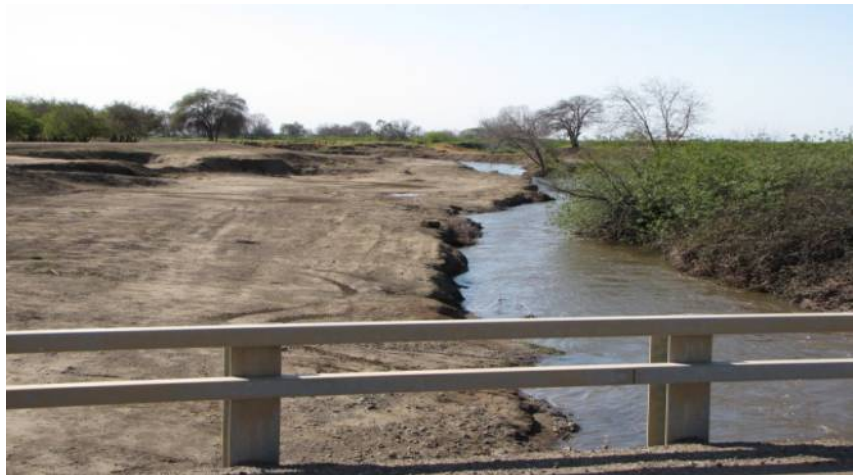
Report Line	11
Location	Water Side
Category	Rivers, Channels & Designated Floodways
Item	Vegetation & Obstructions
Looking downstream Mariposa Creek from Plainsburg Rd. Some erosion exist on left bank waterside downstream of Plainsburg crossing.

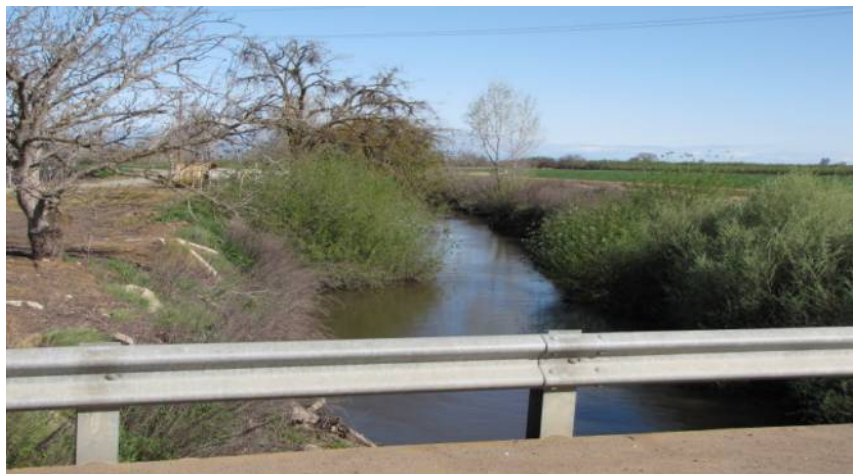
Report Line	12
Location	Water Side
Category	Rivers, Channels & Designated Floodways
Item	Vegetation & Obstructions
Looking upstream Mariposa Creek from Whealan Rd. Minimal growth in channel up from bridge.

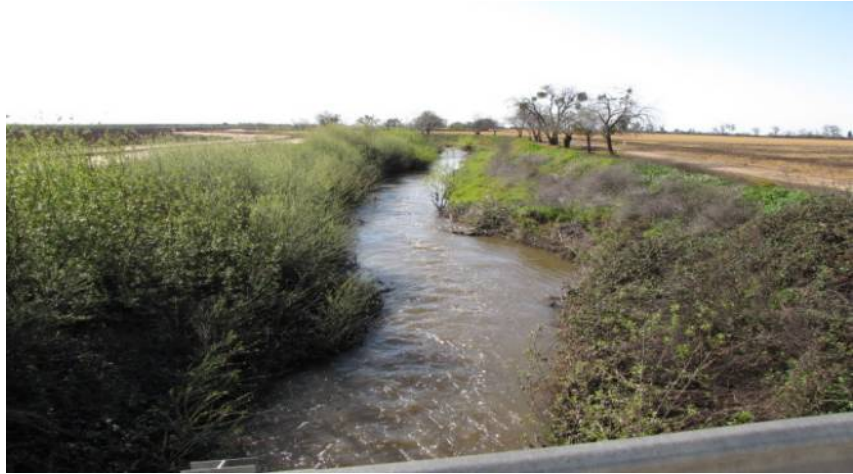
Looking downstream Mariposa Creek from Whealan Rd. Some growth on both banks.

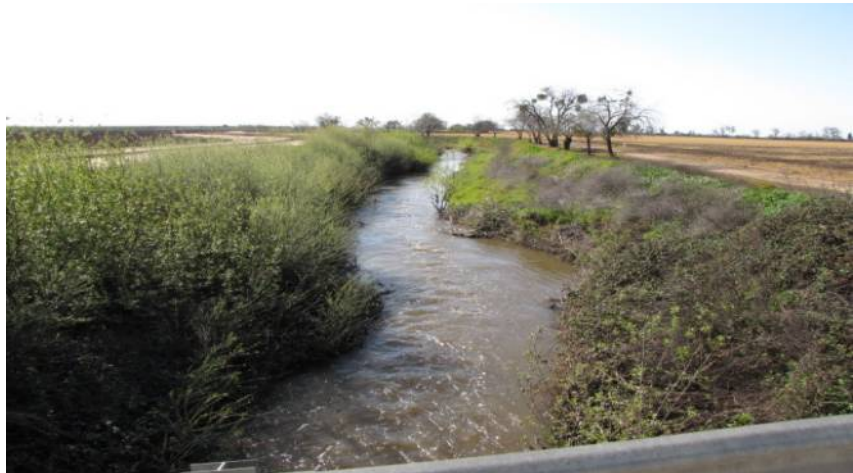
Report Line	15
Location	Water Side
Category	Rivers, Channels & Designated Floodways
Item	Vegetation & Obstructions

LOOKING UPSTREAM Mariposa Creek from Arboleda Drive. Some berries remain in channel right bank and willows present on left bank, channel still able to flow water.

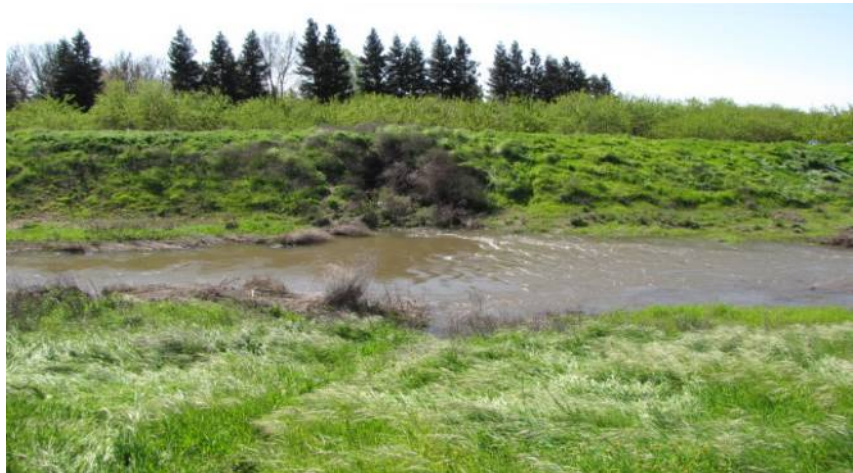
Report Line	18
Location	Water Side
Category	Rivers, Channels & Designated Floodways
Item	Erosion
Wier in Mariposa Creek, just downstream from Burchell Avenue. Note the erosion is getting larger from last inspection. The growth blocks the view.

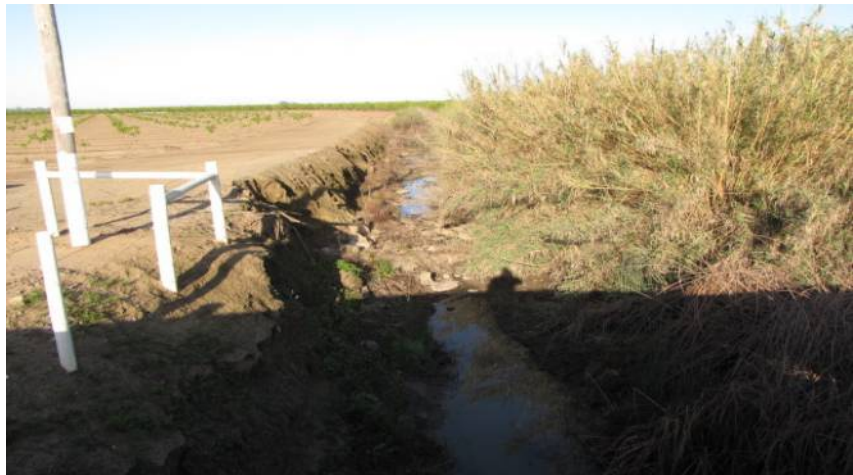
Looking downstream Miles Creek from Highway 59, wild growth of Bambo on right bank.

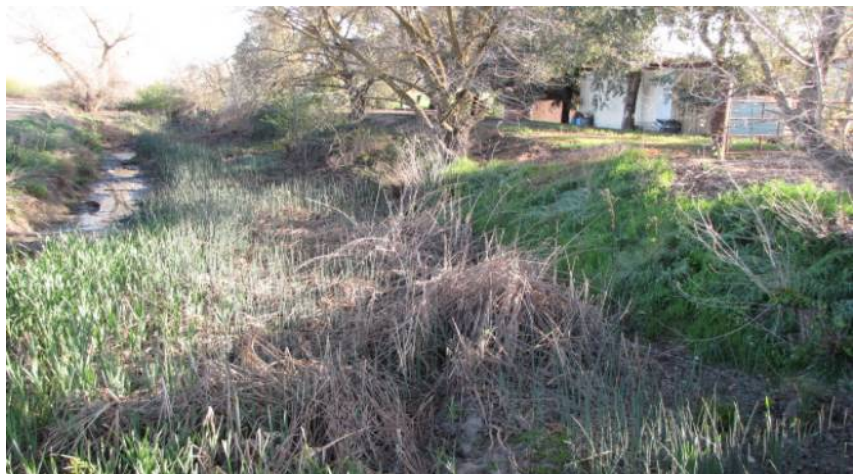
Report Line	2
Location	
Category	Rivers, Channels & Designated Floodways
Item	Vegetation & Obstructions

Looking upstream from Miles Creek from Reilly Road. Channel overgrown with tules.

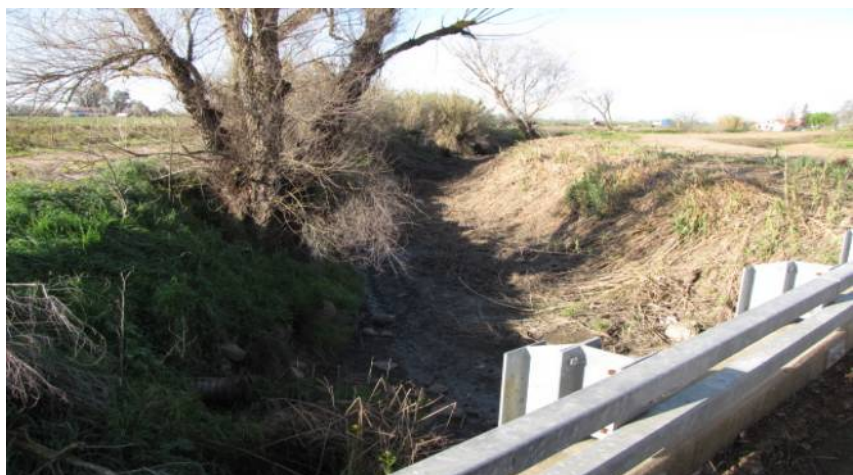
Report Line	3
Location	
Category	Rivers, Channels & Designated Floodways
Item	Vegetation & Obstructions

Looking downstream Miles Creek from Reilly Road. Bambo has been sprayed from right bank look like atleast 100 yards from bridge.

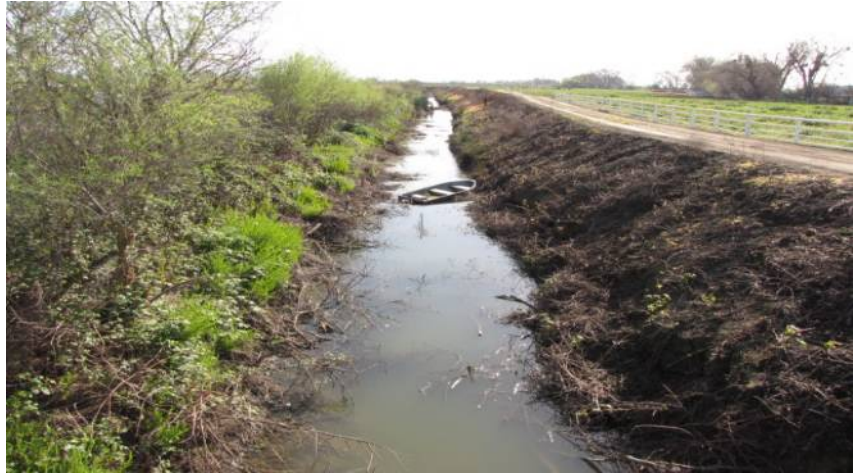
Looking upstream MilesCreek from Healy Road. Left bank has been sprayed to remove the berryvines. This boat belong to resident.

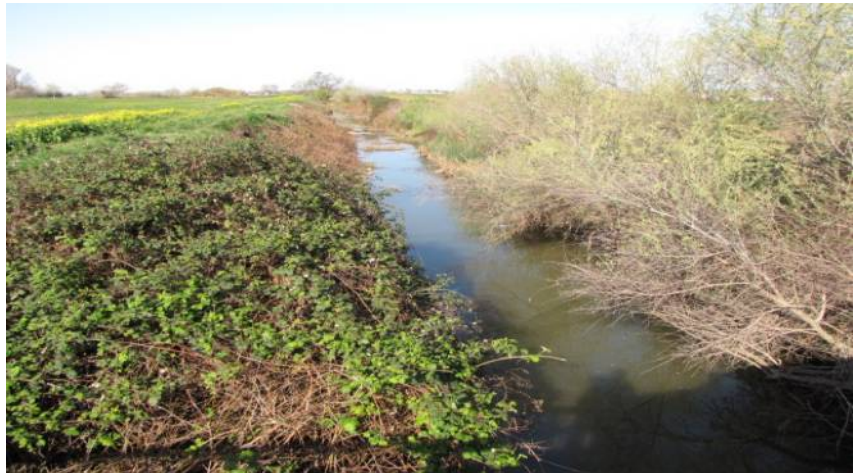
Report Line	8
Location	
Category	Rivers, Channels & Designated Floodways
Item	Vegetation & Obstructions

Looking downstream Miles Creek from Healy Road. Wild growth of berries on right bank, left bank has growth of willow trees.

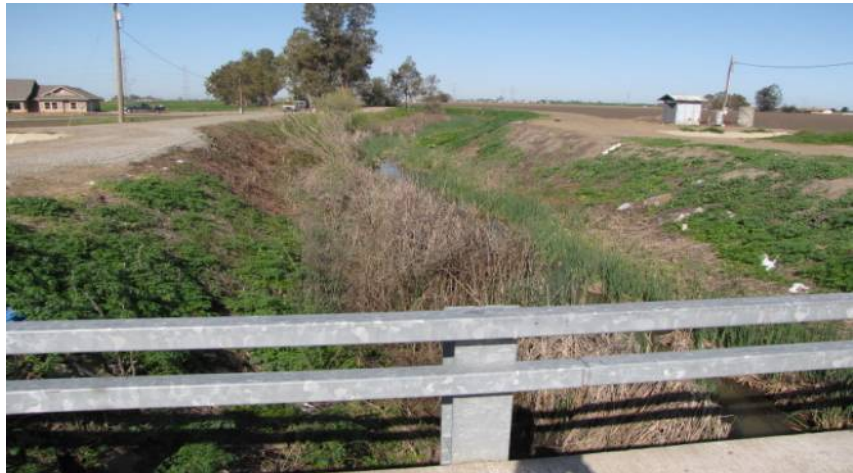
Report Line	10
Location	
Category	Rivers, Channels & Designated Floodways
Item	Vegetation & Obstructions

Looking downstream Miles Creek from Orchard Drive. Tules has been sprayed.

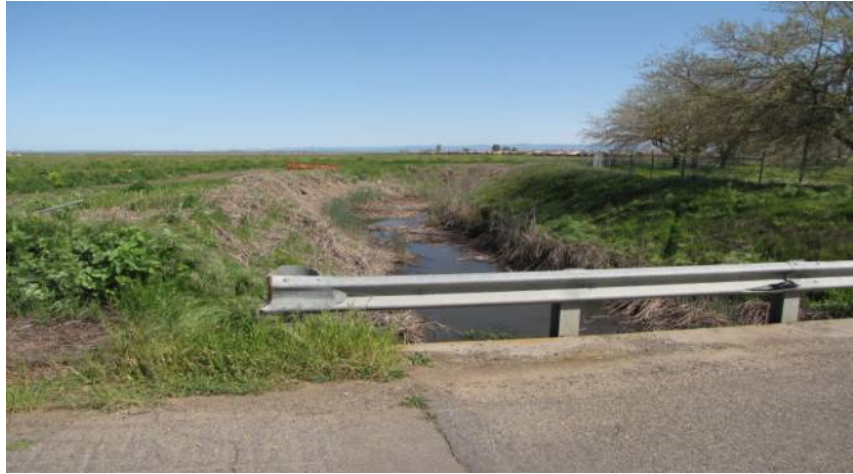
Report Line	18
Location	
Category	Rivers, Channels & Designated Floodways
Item	Vegetation & Obstructions
Looking upstream Miles Creek from Gerard Ave. Channel has been cleared.

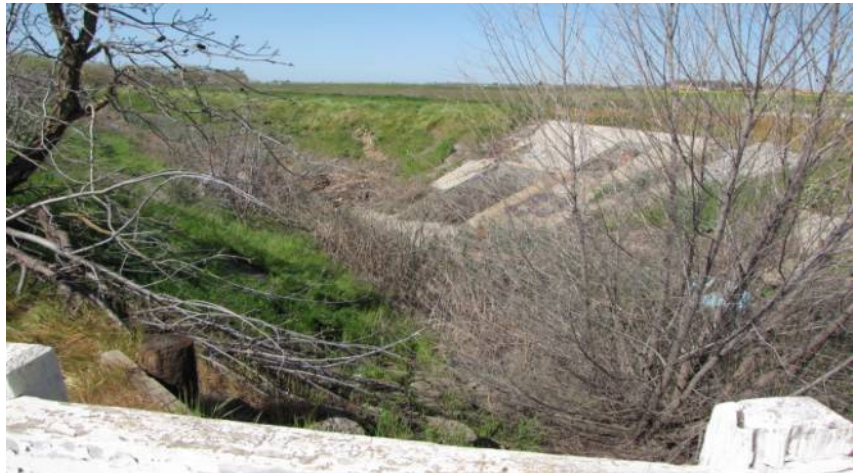
Report Line	19
Location	
Category	Rivers, Channels & Designated Floodways
Item	Vegetation & Obstructions
Looking downstream Miles Creek from Plainsburg Bridge. Tree growth at bridge.

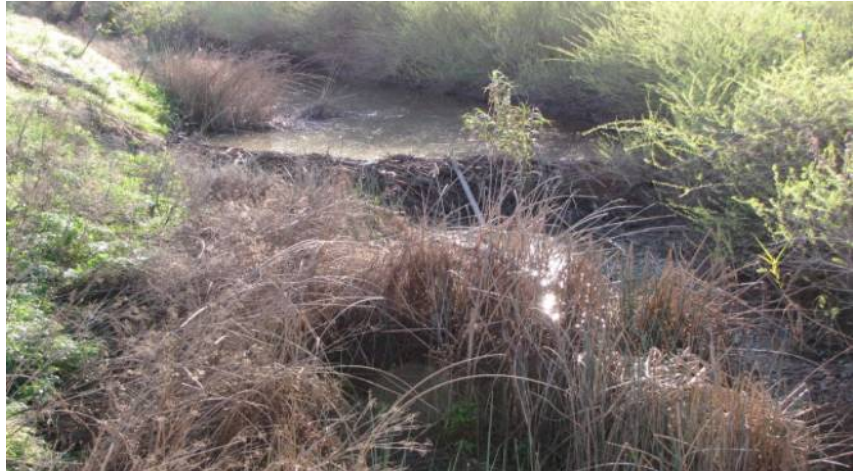
Report Line	25
Location	
Category	Rivers, Channels & Designated Floodways
Item	Encroachments

Looking upstream Miles Creek from Highway 59. Note the earthen dam placed across channel. Tules are present in channel Along with young willows.
